Assessment of Safety Measures in RMG Sector of Bangladesh

Master of Engineering

November 2019

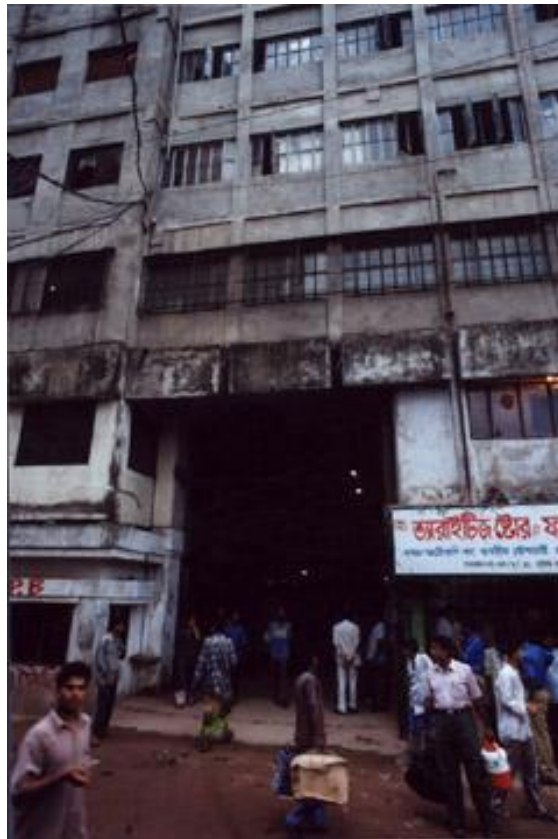
Fig. 2.1: Macro Sweater Tragedy

The tragedy took place in the Mirpur area of Dhaka on the morning of August 8, 2001. At 9 a.m., after seeing flames shooting from the electric circuit board, a worker at Macro Sweater Ltd. on the seventh floor of the building sounded the alarm. Workers from five different units converged on the stairs, but the one exit was locked and the security guard was absent. Twenty four workers died in the ensuing stampede and more than one hundred were injured (Geertjan, 2013 B).

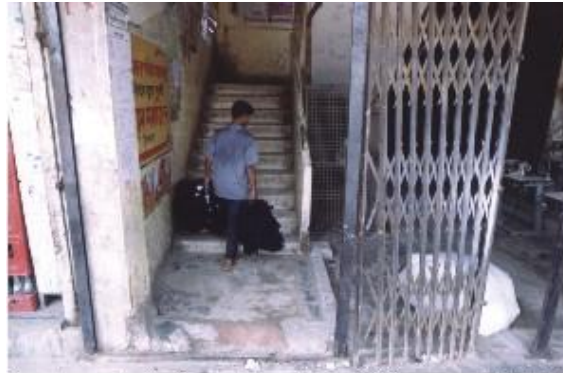
Fig. 2.2: Misco Supermarket complex

The gate was locked by volunteers' of a religious group that held a programme in the adjacent ally.

Most of them rushed through the main stairway where they found the gate locked. This caused the death of nine young women who were trampled to death in the ensuing stampede. Fifty others were injured (Geertjan, 2013 A).

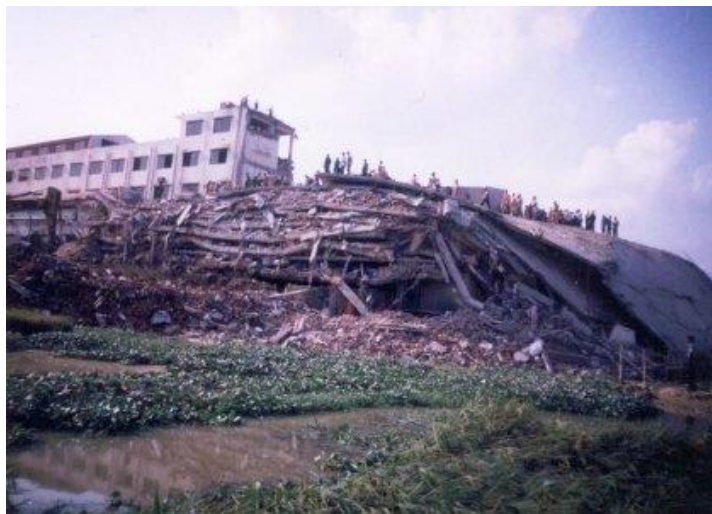
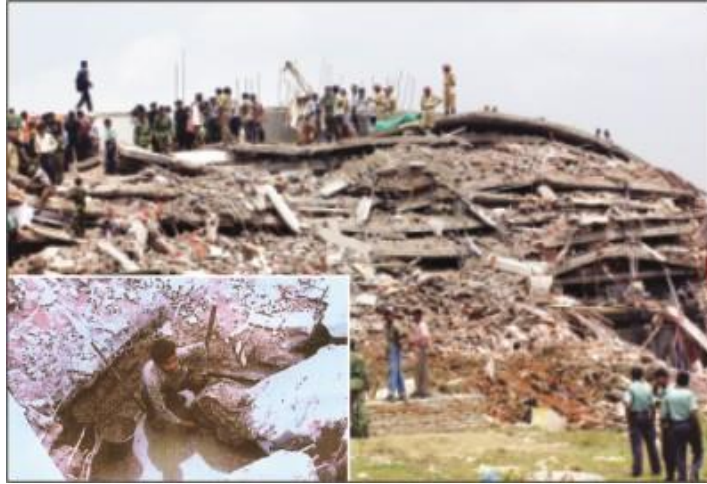
Fig. 2.3: Spectra Sweater

The collapsed nine story building is located east of the Shahriar Garments Factory and is further east adjacent to a ditch. The same owner belongs to both the factories. The fall took place without warning in a sudden failure.

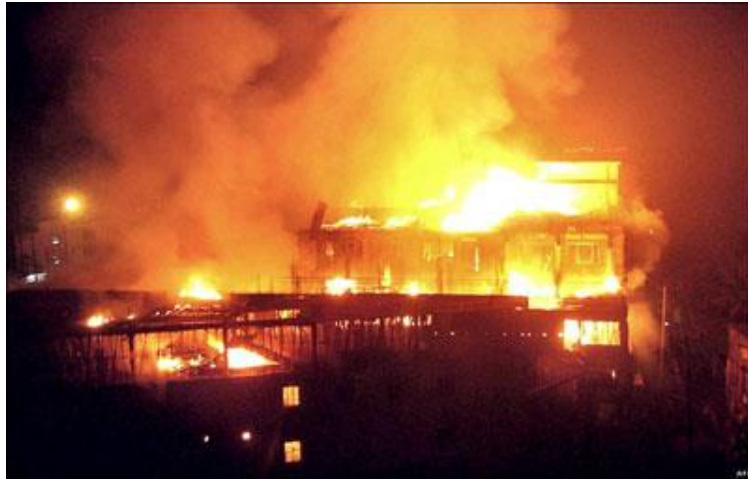
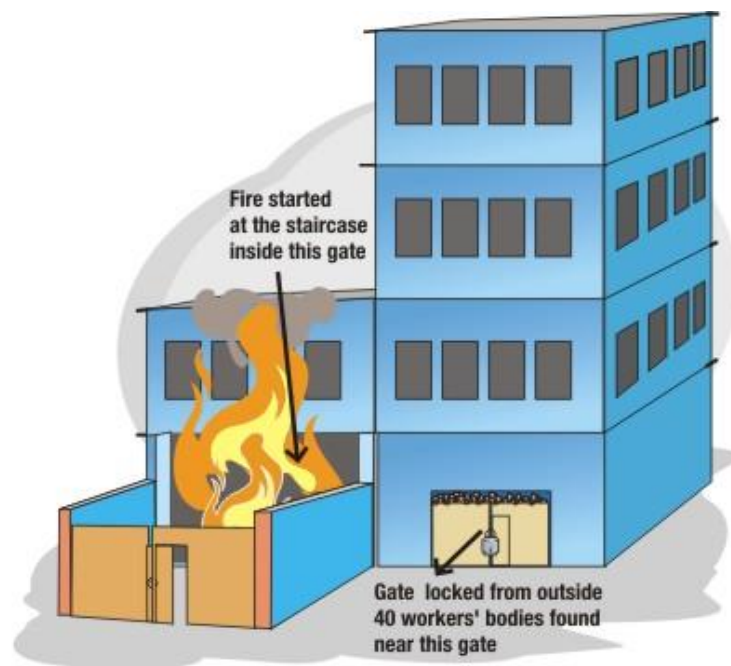
Fig. 2.5: KTS Textile

23 February 2006, when the four story KTS Textile Industries in Bangladesh's port city of Chittagong was destroyed by a fire, possibly caused by an electrical short circuit. Initial reports suggested that 54 have been killed and at least 60 have been injured, but other sources peg the death toll to several hundred in what advocates for local clothing workers' rights term the worst disaster in Bangladesh clothing industry history. It is estimated that more than 1,000 employees were in the factory at 7 p.m. The exits have been closed, according to the staff. In 2005, at the same facility situated in the Kalurghat Industrial Area, two electricians allegedly died when they were electrocuted. Uni Hosiery, Mermaid International, ATT Enterprise, and VIDA Enterprise Corp. reportedly produced this facility for U.S. companies. Meanwhile, authorities have apparently sealed off three other factories linked to this facility (Vintex Fashion, Cardinal Fashion and Arena Fashion) citing unplanned construction and inadequate safety measures as life threatening for their more than 6,000 workers (Skeers, 2006).

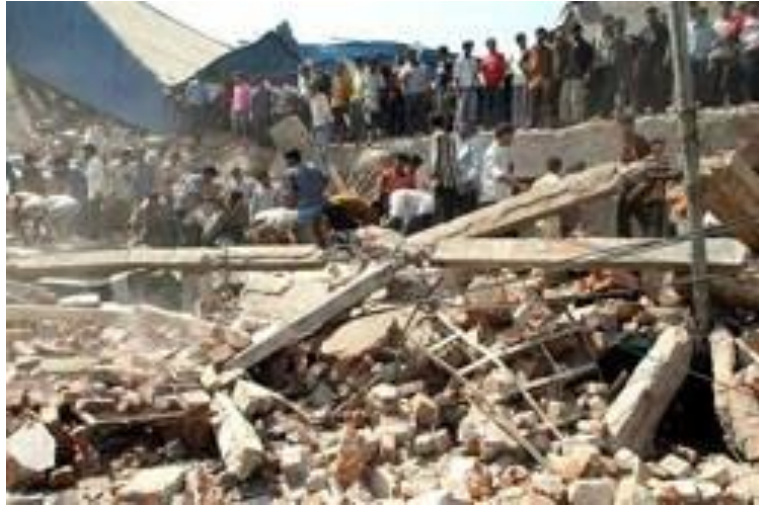
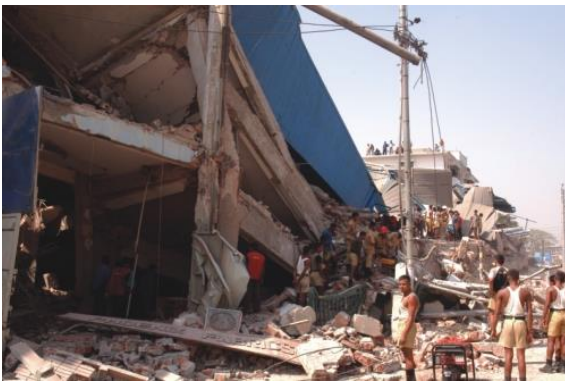
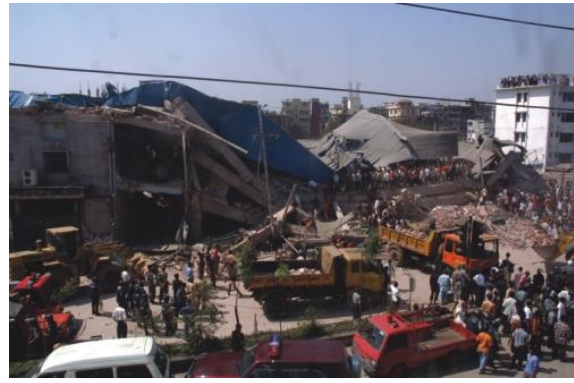
Fig. 2.6: Phoenix Building

On February 24, 2006, after unauthorized renovations, the Phoenix Building in the industrial area of Tejgaon collapsed to convert the upper floors of the building that housed various offices and factories, including a garment factory, into a private hospital of 500 beds. A hundred and fifty construction workers and an unreported number of garment workers were reportedly in the building when it collapsed on Saturday morning. Phoenix Garments exports clothing mainly to Europe (Correspondent, 2013).

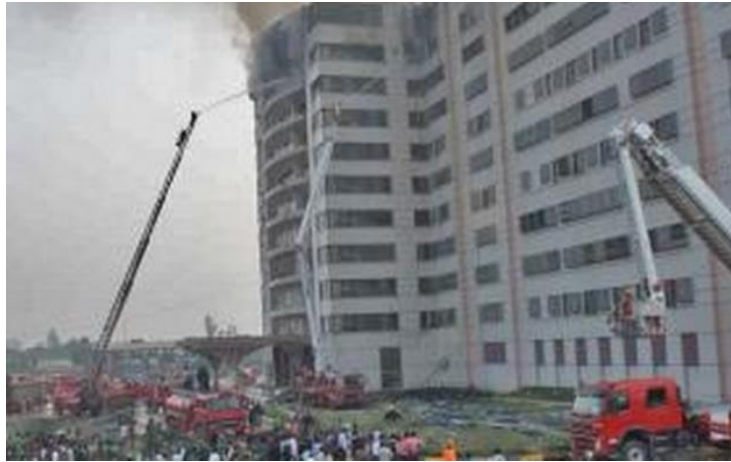
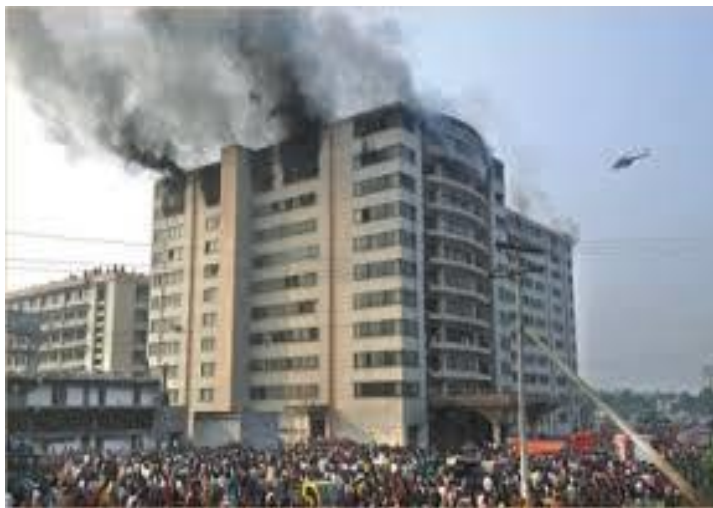
Fig. 2.7: Hameem Group

Witnesses said the blaze engulfed the multi-story building at the factory just outside Dhaka, forcing some of those trapped inside to jump out of the windows. The fire comes at factories making clothes for western retailers despite repeated warnings about fire safety. Authorities said that the fire initially broke out on the building's 10th floor, where trousers were stored for shipment, and then spread up to the 11th floor where there was a canteen and

a production facility. At least 27 people died in the blaze while one witness said he saw between 50 and 60 people jumping to escape from the 10th floor. Local business giant Hameem Group owned the factory in the industrial zone of Ashulia, 18 km away from Dhaka. The Hameem Group has two on-site manufacturing facilities employing around 12,000 workers. The fire broke out in a building that employs about 6,000 people (Sarkar and Mollah, 2010).

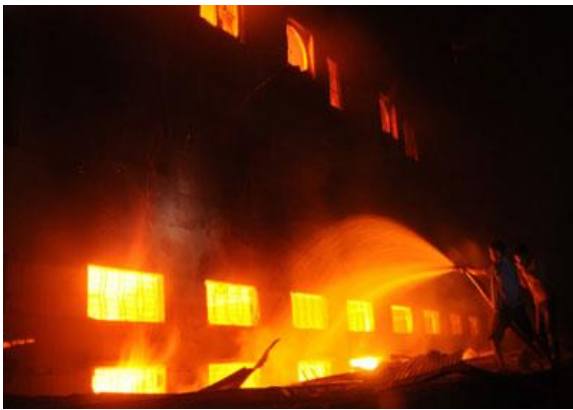
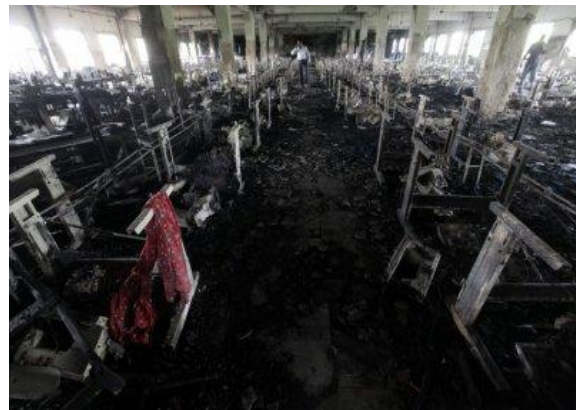
Fig.2.8: Tazreen Factory (part of Tuba Group)

The fire at the Tazreen Factory (part of the Tuba Group) outside Dhaka on November 24, 2012 resulted in the deaths of at least 120 employees. The precise death toll is unknown as some employees have actually disappeared, possibly burnt beyond recognition.

When the fire came out of the workers' control, they could not escape. As a result, when jumping from the upper floors, many were burned or suffocated in the factory, or killed or injured. It was not possible even to escape from the upper floors as the doors were barred. Most employees are forced to break and leap through the blades of giant extractor fans.

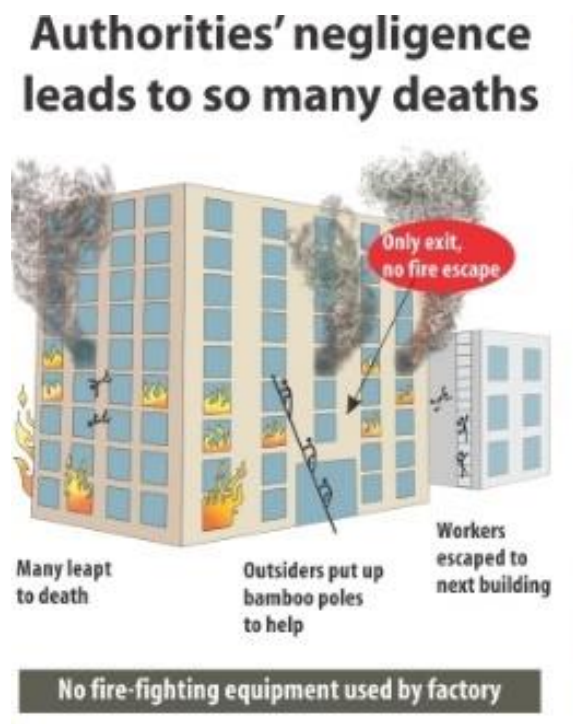
Fig. 2.9: No fire escape provision

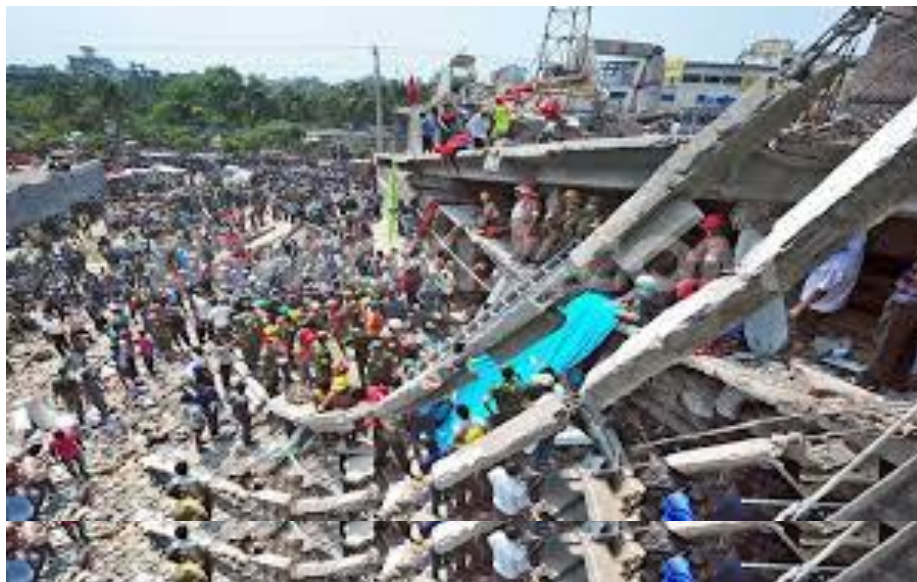
Fig. 2.10: Rana Plaza

The collapse of Bangladesh's Rana Plaza factory building is the worst industrial accident ever to strike the fashion industry. The Rana Plaza building crashed on 24 April 2013, killing 1,134 people and injuring thousands more.

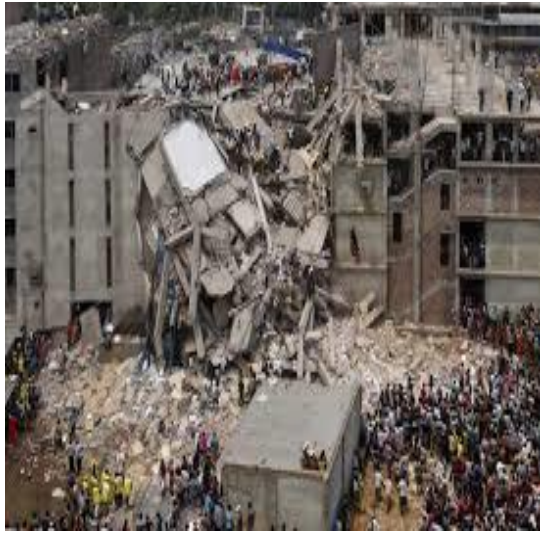
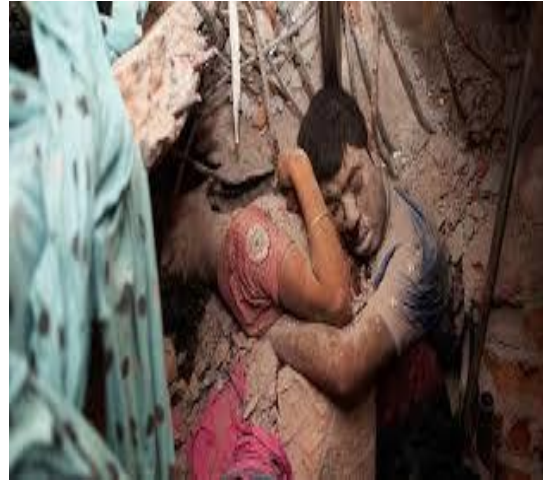
Fig. 2.11: Rana Plaza Tragedy

Rana Plaza's collapse brought worldwide attention to workplaces in the garment industry in the death trap. Public interest and media attention have resulted in more political pressure than ever before to bring about change and have resulted in significant ground breaking approaches to prevention and redress, with the creation in Bangladesh of the binding Fire and Building Safety Agreement and the Rana Plaza Agreement involving all major players to reimburse victims and families (Wikipedia 2013).

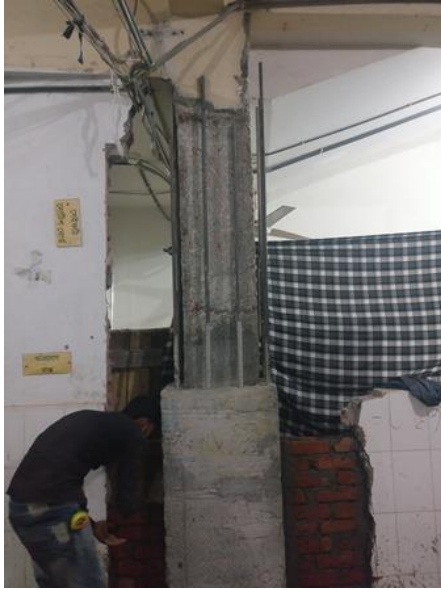
Fig. 5.6: Column Retrofitting

From table 5.1, we can see that all the factories other than Sumi Apparels are struggling in structural remediation. From the Corrective action plan of the factories we can see that there are issues like overstressed columns, overloading, undocumented extensions of the buildings, missing as-built information, Detail Engineering Assessment (DEA) requirement, etc. Analysis the CAP it was observed that most of the factories struggled to get the DEA approved from Accord and after approval most of the factories required retrofitting work. During the retrofitting work, total project is planned considering production pressure, disturbance of work due to retrofitting work, safety during retrofitting, shifting of work station etc. A typical Gantt chart is prepared to divide the whole project in phases. This whole management process is implemented the site engineer, compliance team, worker participation committee etc.
