**Macro-cell and Micro-cell Corrosion of Steel in
Concrete with Different Interfacial Transition Zones
(ITZ) and Variations of Seawater Concentrations**

A THESIS SUBMITTED FOR THE DEGREE OF BACHELOR OF SCIENCE
IN CIVIL ENGINEERING (STRUCTURE)

**DEPARTMENT OF CIVIL AND ENVIRONMENTAL ENGINEERING
ISLAMIC UNIVERSITY OF TECHNOLOGY (IUT)**

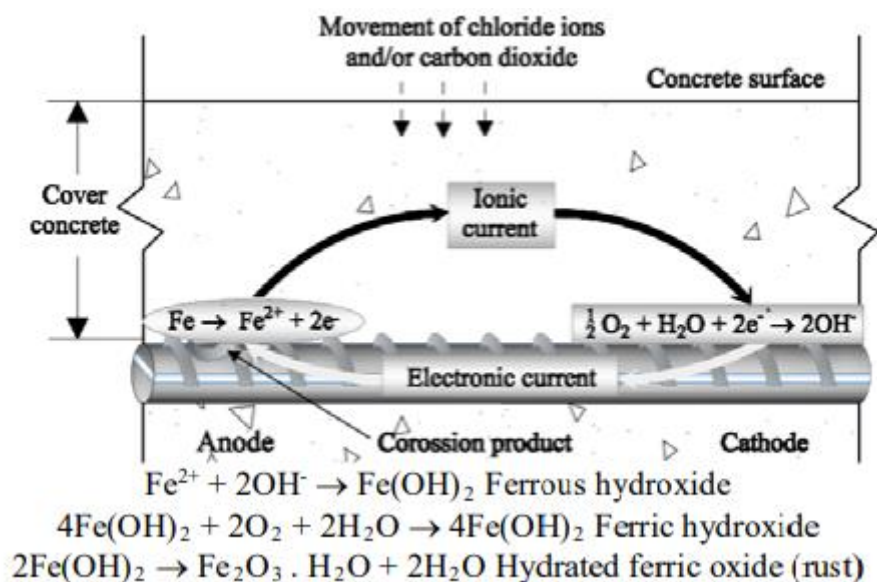
Figure 2: Component of corrosion reaction on rebar in concrete. [12]

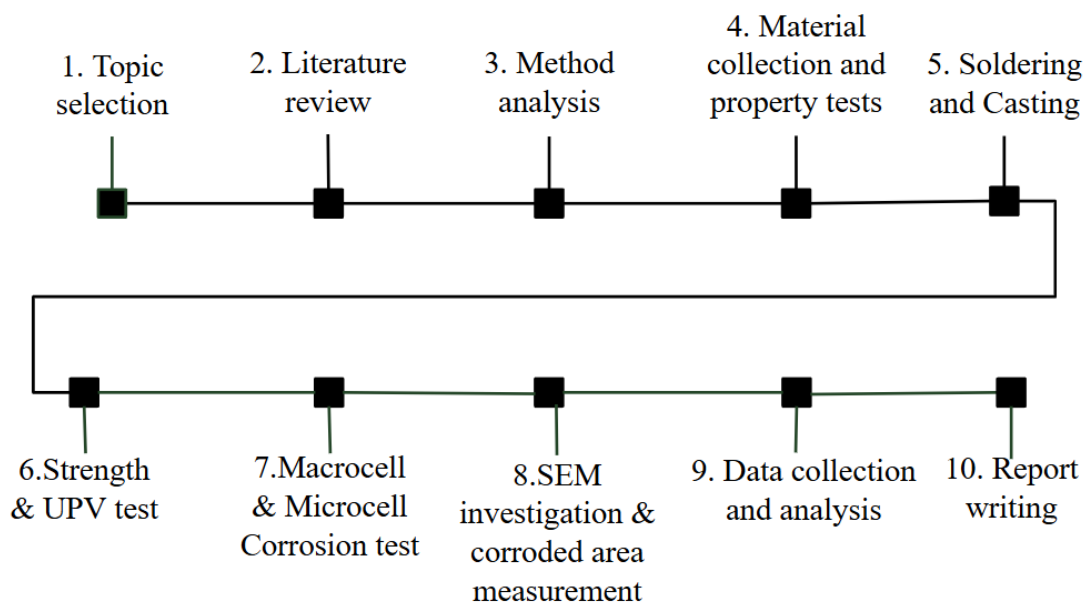
Figure 3: Research flow diagram

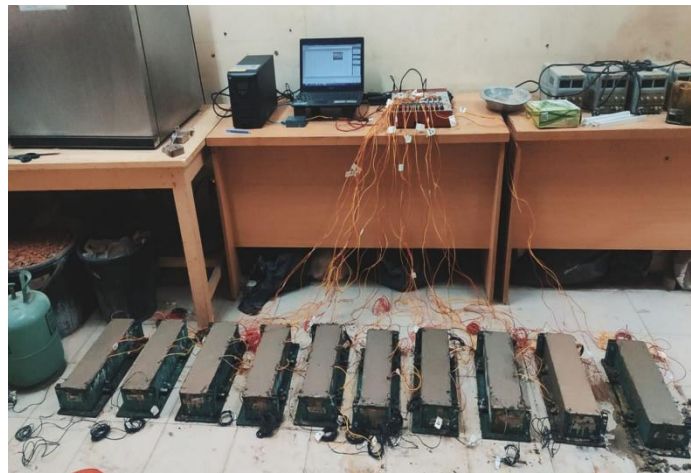
Figure 6: Connection of rebars with data logger

A data logger (TDS 150) was used to record the voltage drops at 90 predefined intervals. As the specimens were created using seawater in concrete mixing, macro-cell corrosion started right after the casting. The specimens were connected with the data logger immediately after casting to measure macro-cell corrosion current. The concrete covering had a thickness of 20 mm. Following casting, the prism specimens were allowed to cure for ninety days under wet jute bags that were securely sealed with polythene to keep moisture from escaping.

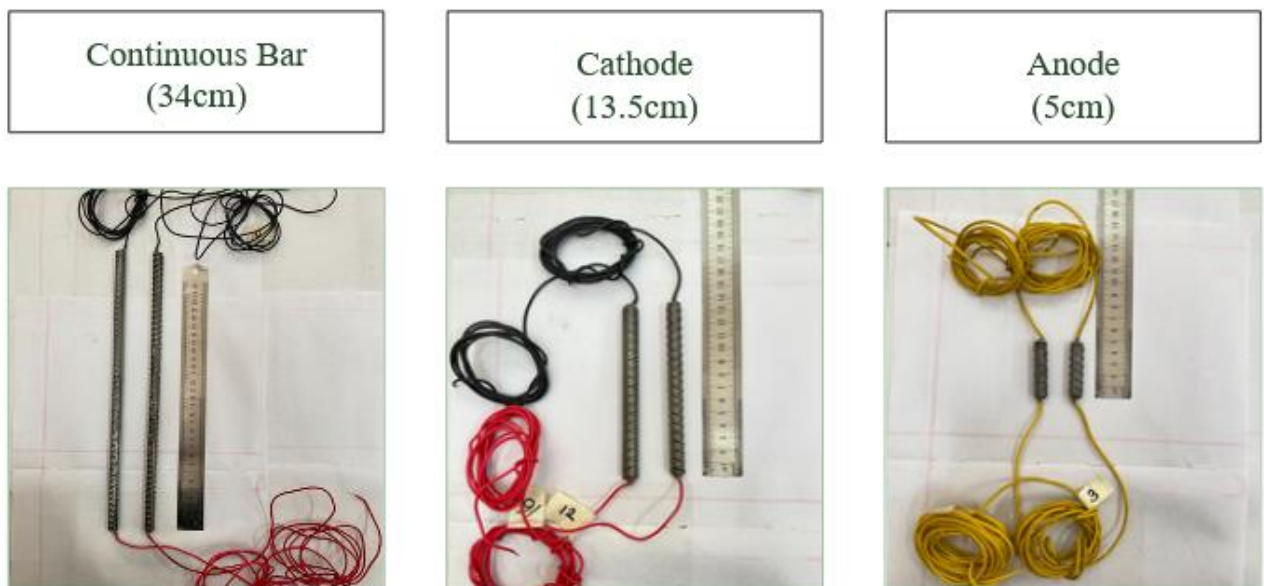
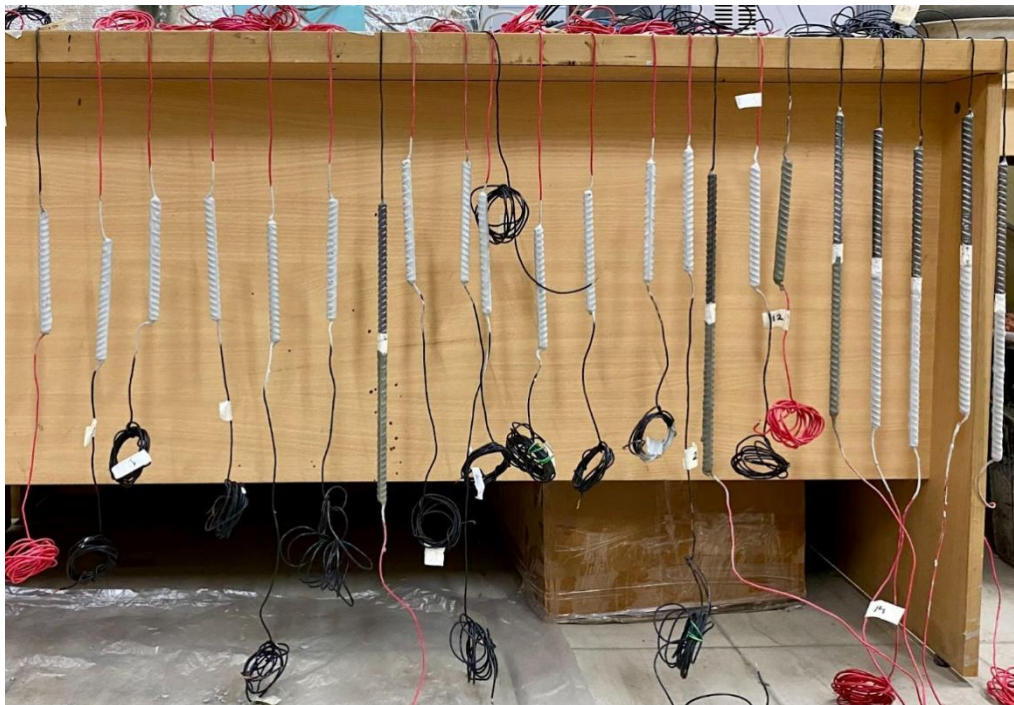
The steel bars were cleansed with a 10% diammonium hydrogen citrate solution. The length of the continuous steel bar is 340 mm which was provided to prevent a collapse of the prism specimen. The segmented steel bar has three parts, two edge segments of 135 mm in length and 50 mm in length in the middle, which were used to measure the macro-cell and micro-cell corrosion current in different regions. The wires were connected by soldering. The orientation of the steel bars in the prism specimens is shown in figure 6. To provide electrical isolation inside the specimens the segmented steel bars were connected by epoxy. The segmented steel bars were electrically connected from the outside of the specimens by electrical wires. A 100-ohm resistor was placed to measure the voltage drop.

Figure 8: Cement coated rebar and the connection of rebar and wires

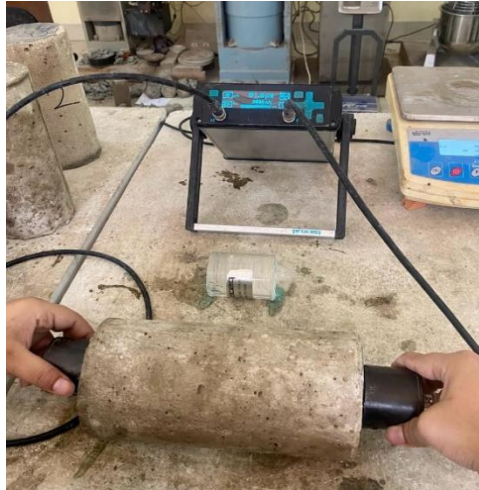
The Ultrasonic Pulse Velocity (UPV) test is a nondestructive method for assessing the homogeneity, quality, cracks, and internal flaws in concrete. We have used an ultrasonic pulse velocity tester to understand the concrete quality using ASTM C597.

Figure 10: UPV test

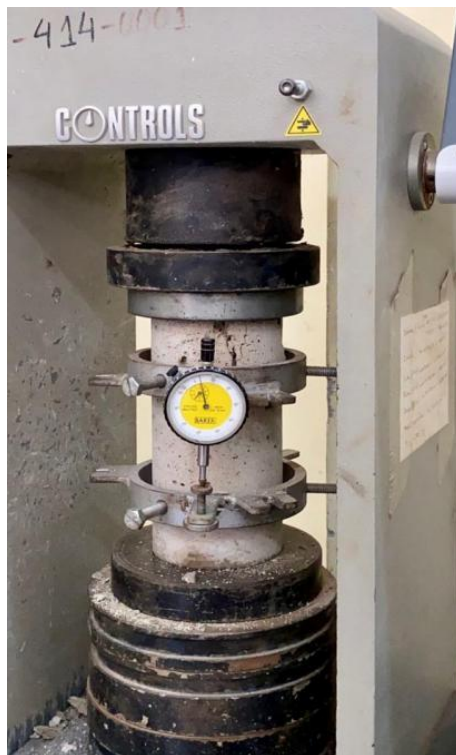
The concrete's compressive strength of ASTM C39 was used to measure the cylinder specimens. We measured the compressive strength of the cylinder specimens (100 mm in diameter and 200 mm in height) after 7 days, 28 days, 56 days, and 90 days.

Figure 11: Compressive strength test

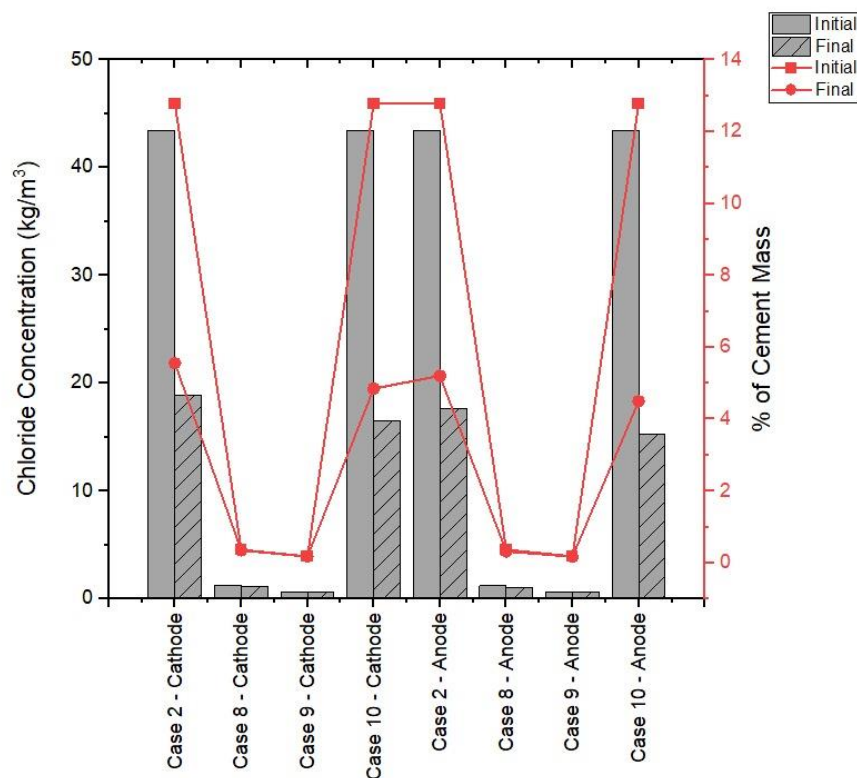
Considering chloride concentrations of case 2 and case 10, initially the percentages of cement mass were high. After the crushing of specimens as powder, the chloride concentration reduced but higher than the threshold limit of chloride against corrosion of steel in concrete (0.4% mass of cement mass). [34]

The reason can be the mixing of cement coating, aggregates with the powdered specimens. For case 8, initial value of chloride concentration was equal to the threshold limit but the final value reduced a bit than the initial value. For case 9, the chloride concentration was half of the threshold limit, although there was little bit corrosion on the steel bar. Therefore, micro-level corrosion was observed in spite of less amount of chloride concentration.

Figure 15: Analysis of chloride concentration along the steel bar

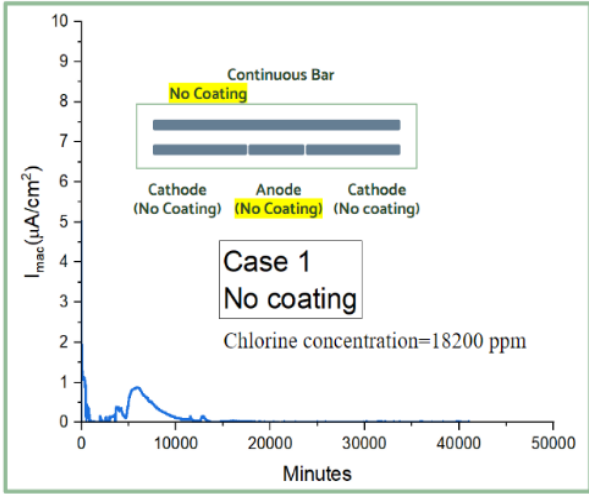
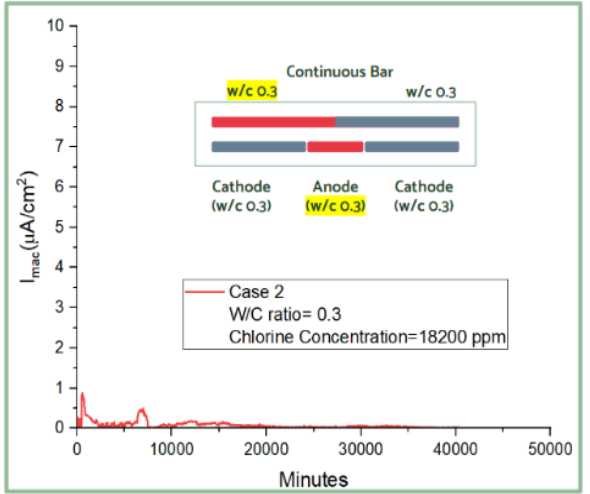
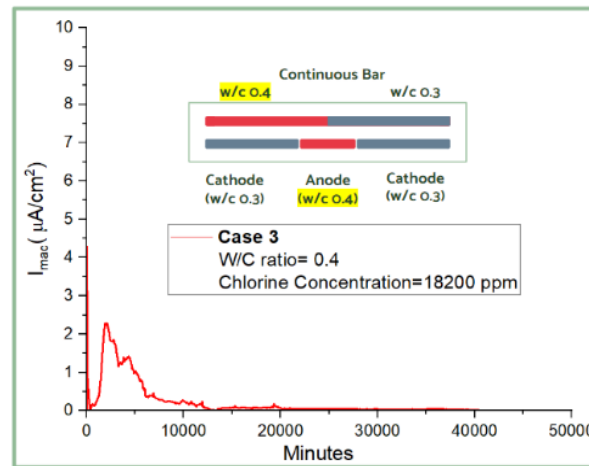
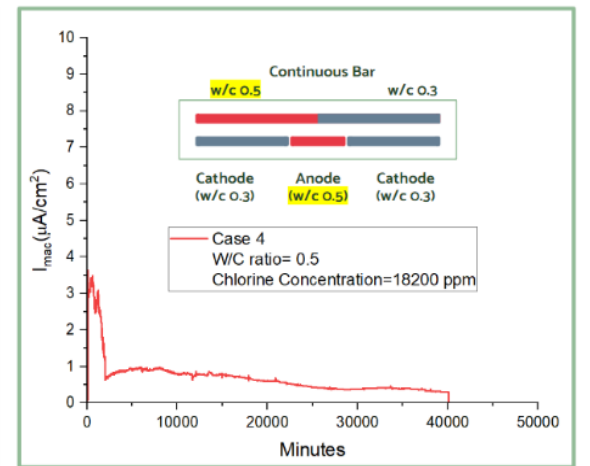
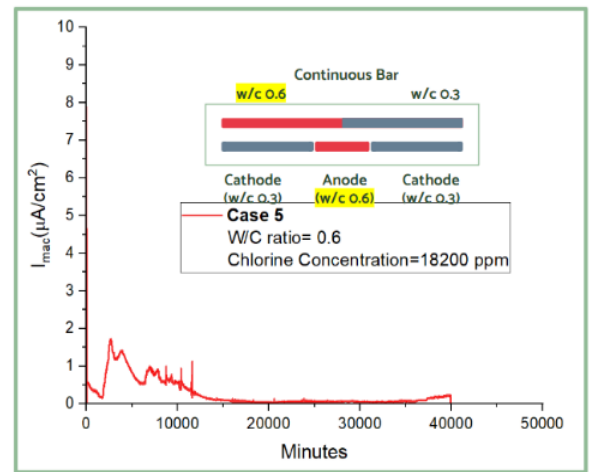
Macro-cell corrosion was found to be dependent on the rebar potential difference, with coated rebars exhibiting lower corrosion rates. Macro-cell corrosion current density measured at the ages of 30 days is shown in figure 16 for different types of specimens. The segmented middle steel bars seem to be anodic with respect to the segmented edge bars. The largest macro-cell current density was found in case 10 which had the maximum porosity in ITZ (coating W/C ratio= 0.9) and maximum chloride concentration (12.7 % of cement mass). The increased porosity in the interfacial transition zone (ITZ) causes higher macro-cell corrosion current density. The smaller macro-cell corrosion current density was shown in case 2 which had the minimum porosity in ITZ (coating W/C ratio 0.3).

Among specimens with identical porosity in ITZ (W/C ratio= 0.8) but different chloride concentrations the smaller macro-cell corrosion current density was shown from the specimen having 0.2% of cement mass. The macro-cell corrosion current density exhibited a negative correlation with chloride concentration. This confirms that lower chloride concentrations lead to decreased corrosion.

Figure 16: Measurement of macro-cell corrosion

To facilitate a more comprehensive comparison of the corrosion of the specimens, the areas under the macro-cell corrosion current density curves presented in Figure 16 were calculated. This data allows for a quantitative assessment of the macro-cell. The results are summarized in Figure 17. It is important to acknowledge that the actual corrosion depth can be significantly higher (ranging from four to eight times greater) than the calculated depth based solely on corrosion current data, as referenced in [37].

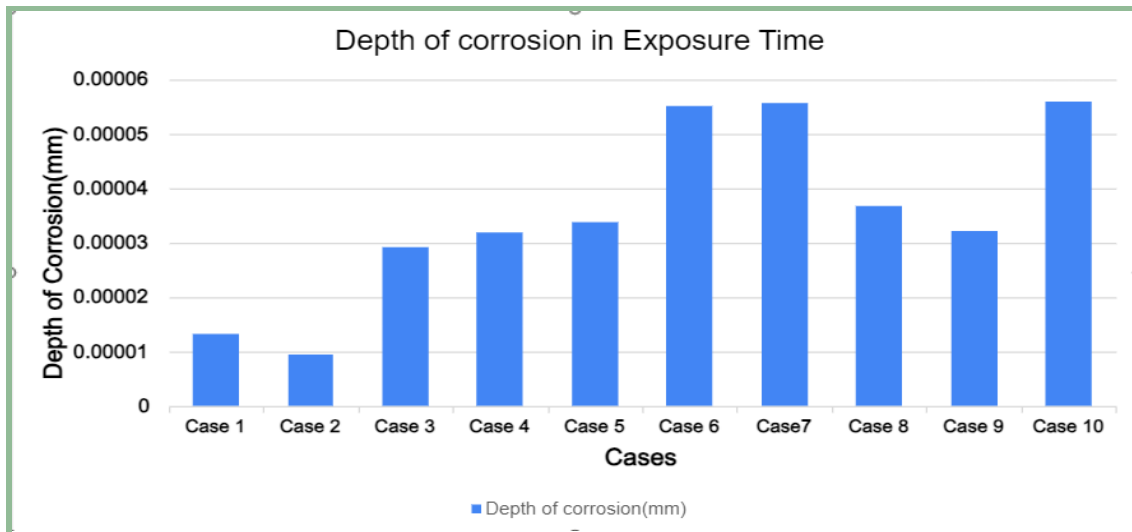
The results indicate the most pronounced corrosion activity for steel bars embedded in concrete containing the maximum amount of chloride content in the coating and maximum porosity in the ITZ. Consistent with the trends observed for macro-cell corrosion, the depth of corrosion increased with a higher water-cement ratio. Notably, Cases 8 and 9, which possessed the lowest

chloride concentration (0.4% of cement content and 0.2% of cement content respectively) among specimens with identical ITZ porosity, exhibited the lowest corrosion depths.

Figure 17: Measurement of depth of corrosion

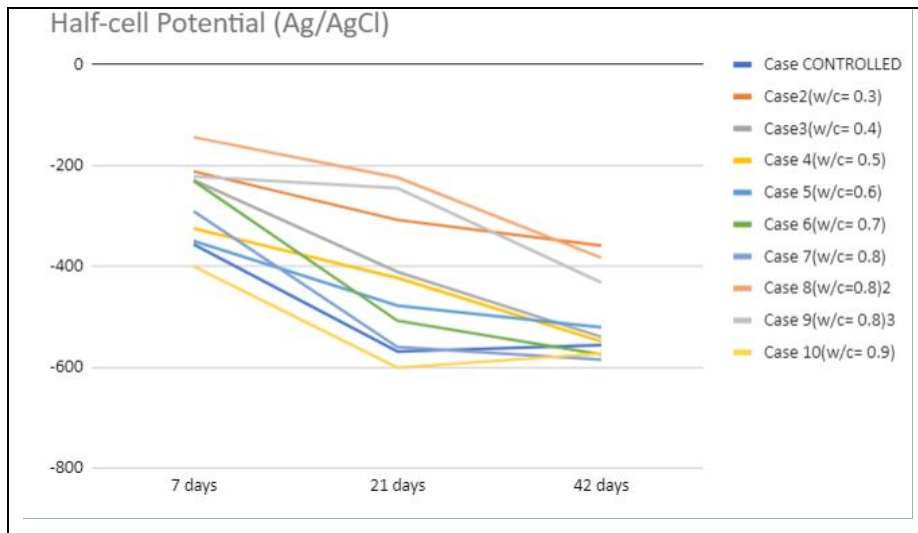
Galvanic corrosion arises when two dissimilar metals or regions within a single material exhibit varying electrical potentials. This potential difference induces the flow of an electrical current between them, ultimately leading to the degradation of the material. Half-cell potential measurements confirmed the segmented middle bar acting as the anode due to its lower potential compared to the right and left bars. This suggests the formation of a weaker interface at the middle bar, promoting its corrosion activity, while denser interfaces formed on the right and left bars, acting as cathodes. From the results, it can be found that HCP values after exposure are increased significantly compared to the HCP values before exposure. These findings highlight the detrimental effect of ITZ porosity on micro-cell corrosion susceptibility and emphasize the importance of optimizing concrete mix design and curing practices to minimize ITZ porosity and enhance concrete durability in marine environments.

Figure 21: Measurement of half-cell potential

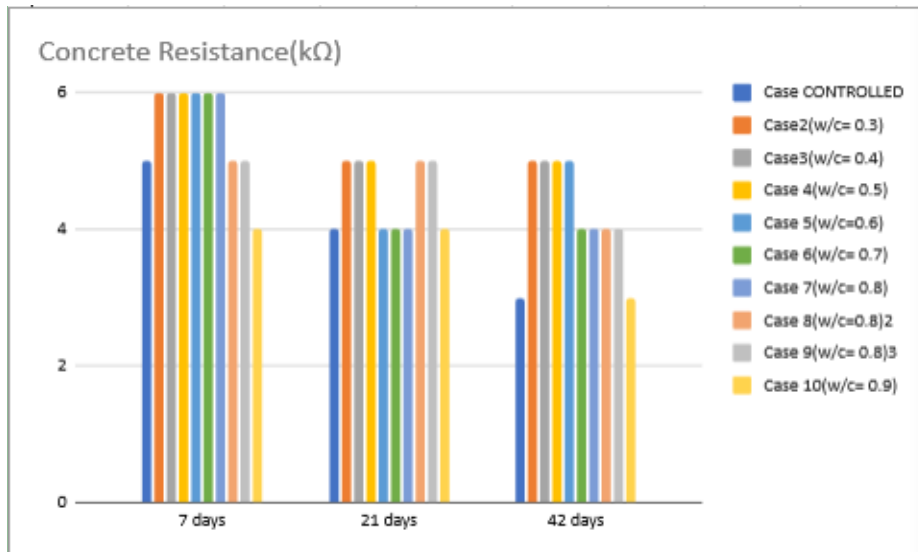
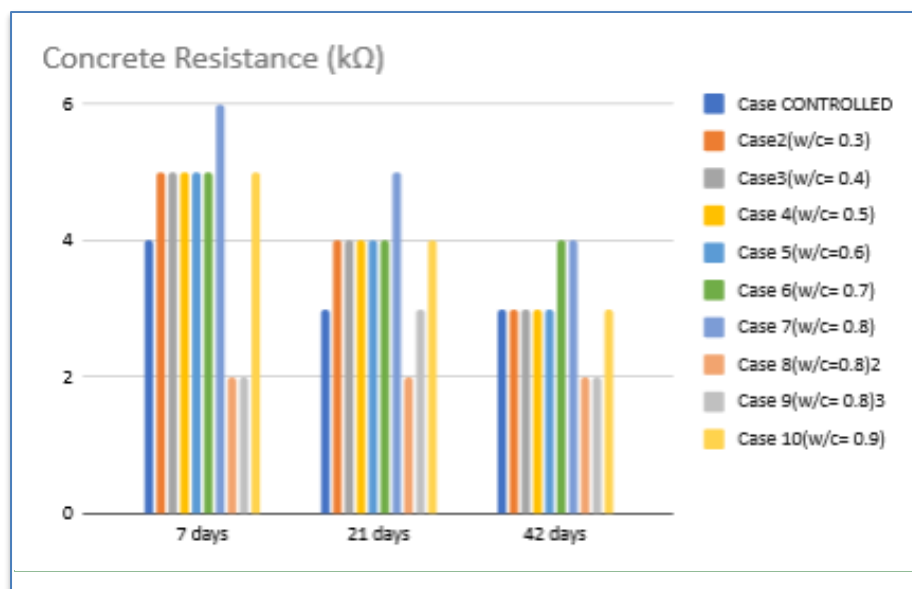
matrix provides a better barrier against corrosion-inducing agents, ultimately protecting the embedded steel. Interestingly, the observed increase in micro-cell corrosion over time suggests a potential future decrease in concrete resistance.

Figure 22: Measurement of concrete resistance

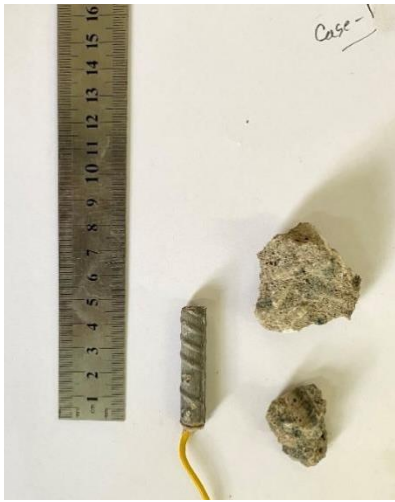
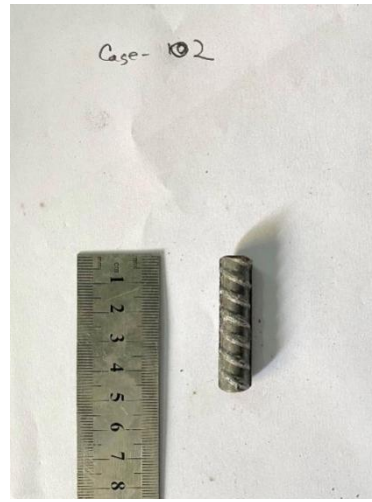
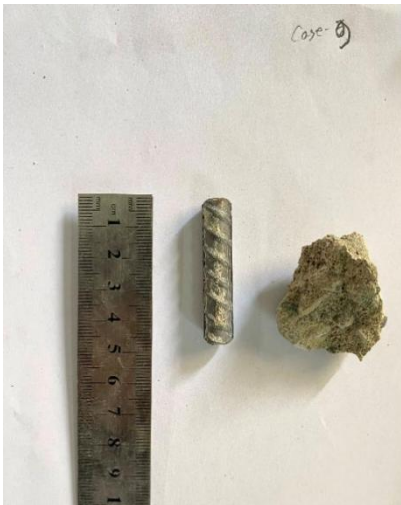
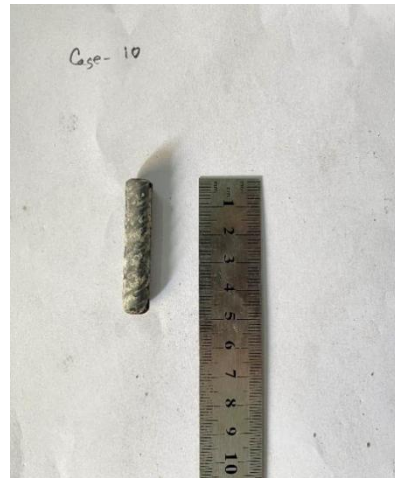
Figure 24: Visual observation of segmented middle steel bar; (a) case 1; (b) case 2; (c) case 9; (d) case 10

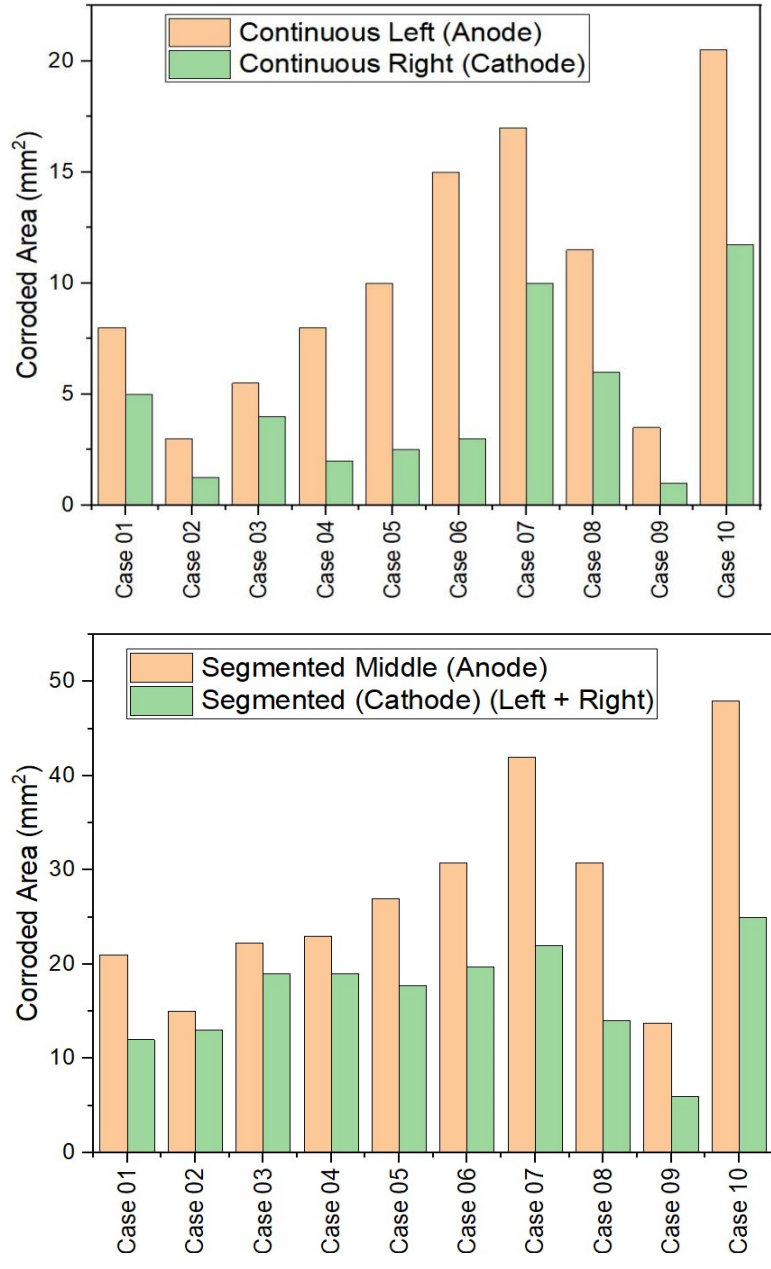
Figure 25: Measurement of corroded area
