Assessment of Safety Measures in RMG Sector of Bangladesh

Master of Engineering

November 2019

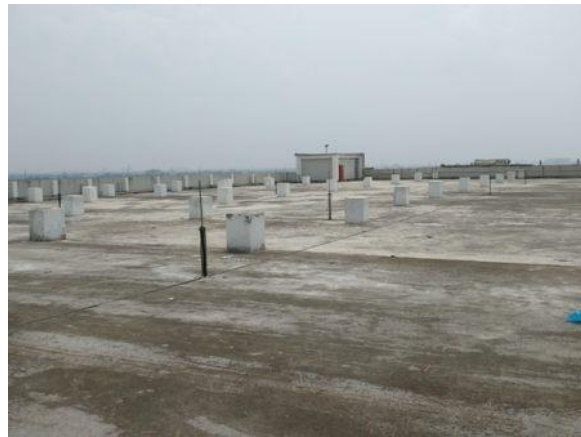
Fig. 5.19: Lightning Protection System (LPS)

due to the fact that, layout of the garment factories changes a lot and change often for this reason electrical layout is also changing. Since this is a continuous process, factories are updating the SLD all the time. Almost all the factories now have Lighting Protection System which was rare before 2014; this system protects factories from power surge during lightning.
